**Report: Chilt/IF10070 AR1 Revision A**

**An ad-hoc fire resistance test performed  
on 4No air transfer grille blocks**

**Test conducted to the temperature and  
pressure conditions outlined in BS 476:  
Part 20: 1987 and the principles of BS  
476: Part 22: 1987**

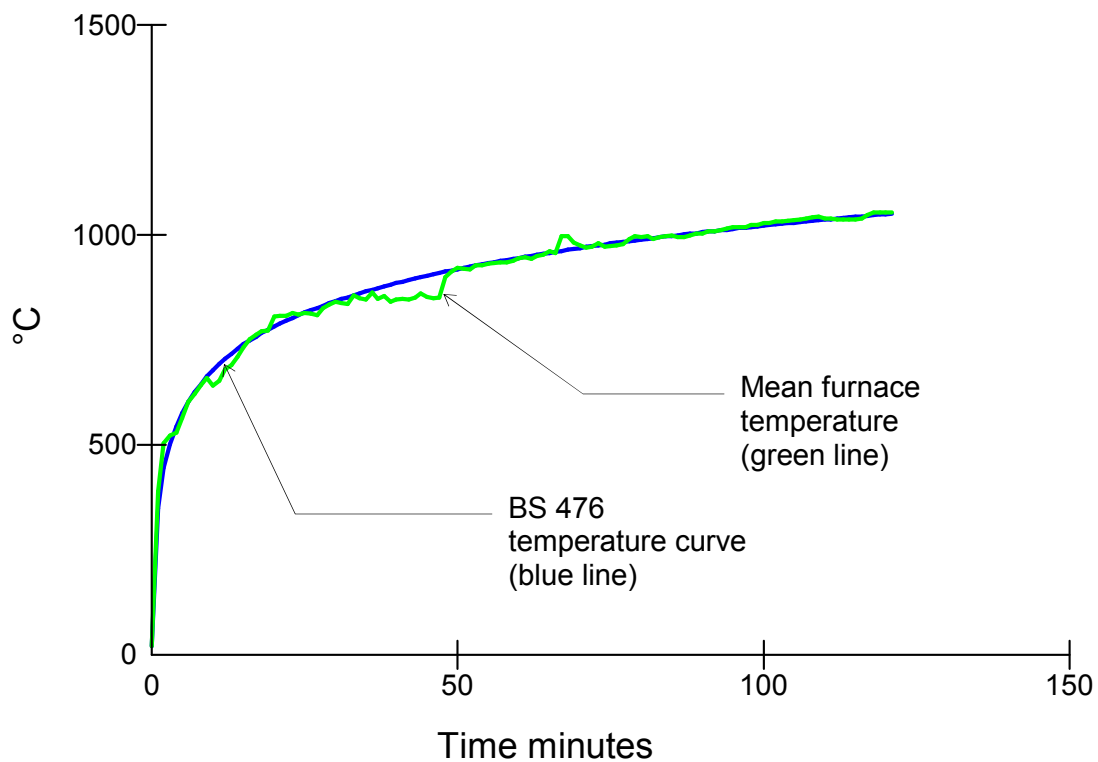
The furnace was controlled to follow the temperature/time relationship specified in BS 476: Part 22: 1987, as closely as possible, using the average of four thermocouples suitably distributed within the furnace. The furnace temperatures for the duration of the test are shown graphically below:

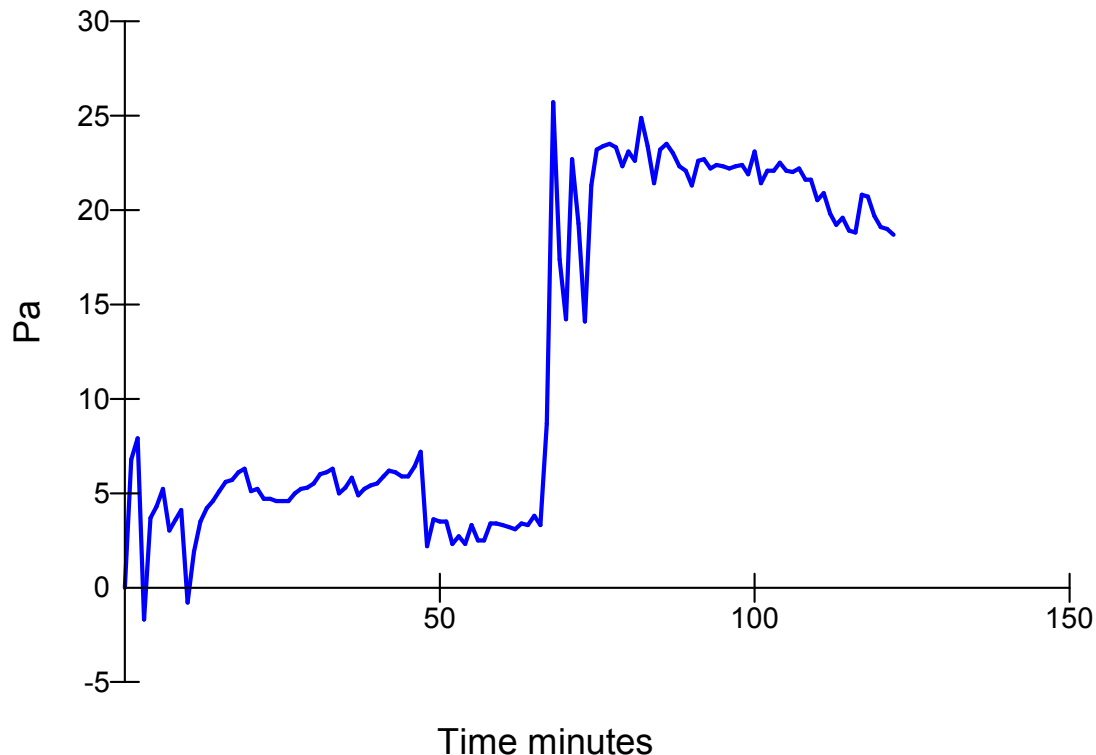
After the first 5 minutes of the test, the furnace pressure was maintained at  $5 \pm 5$  Pa and after 10 minutes was maintained at  $5 \pm 3$  Pa with respect to atmosphere 550mm above the top of the top grille vent, equating to 0Pa at the top of the top grille vents for the first 66 minutes. At the request of the sponsor, the pressure was then increased to  $20\text{Pa} \pm 3$  Pa at the top of the top grille vents for the remainder of the test for indication purposes only. The pressure readings are shown graphically below:

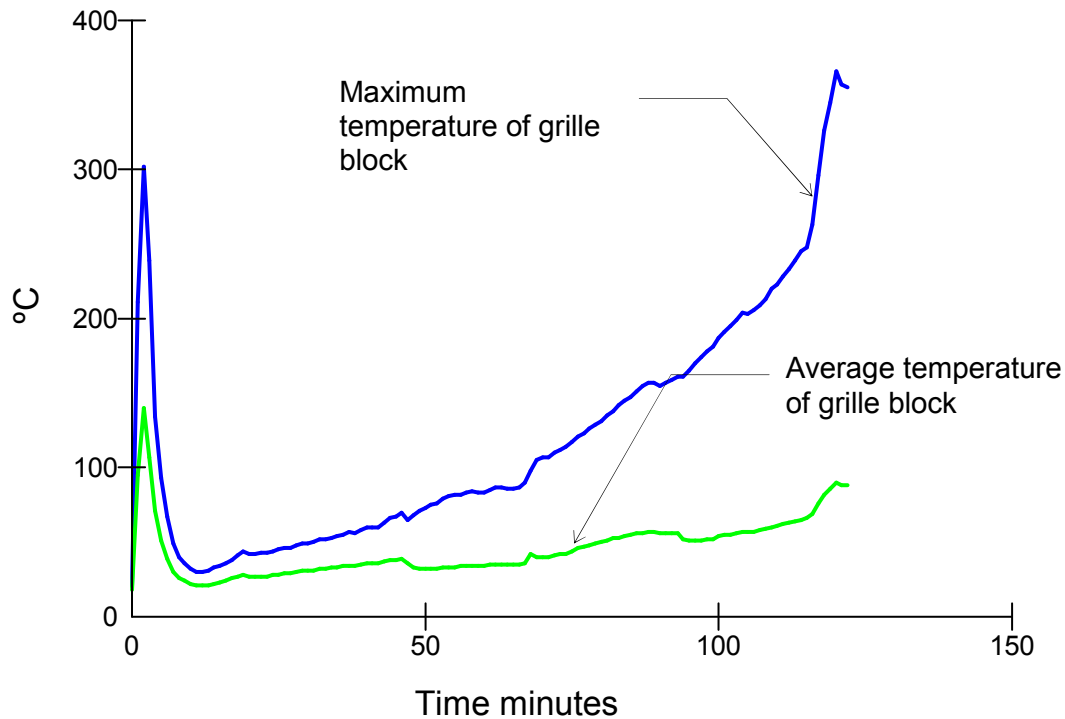
### Air transfer grille block A

## 5.5 Unexposed face temperatures

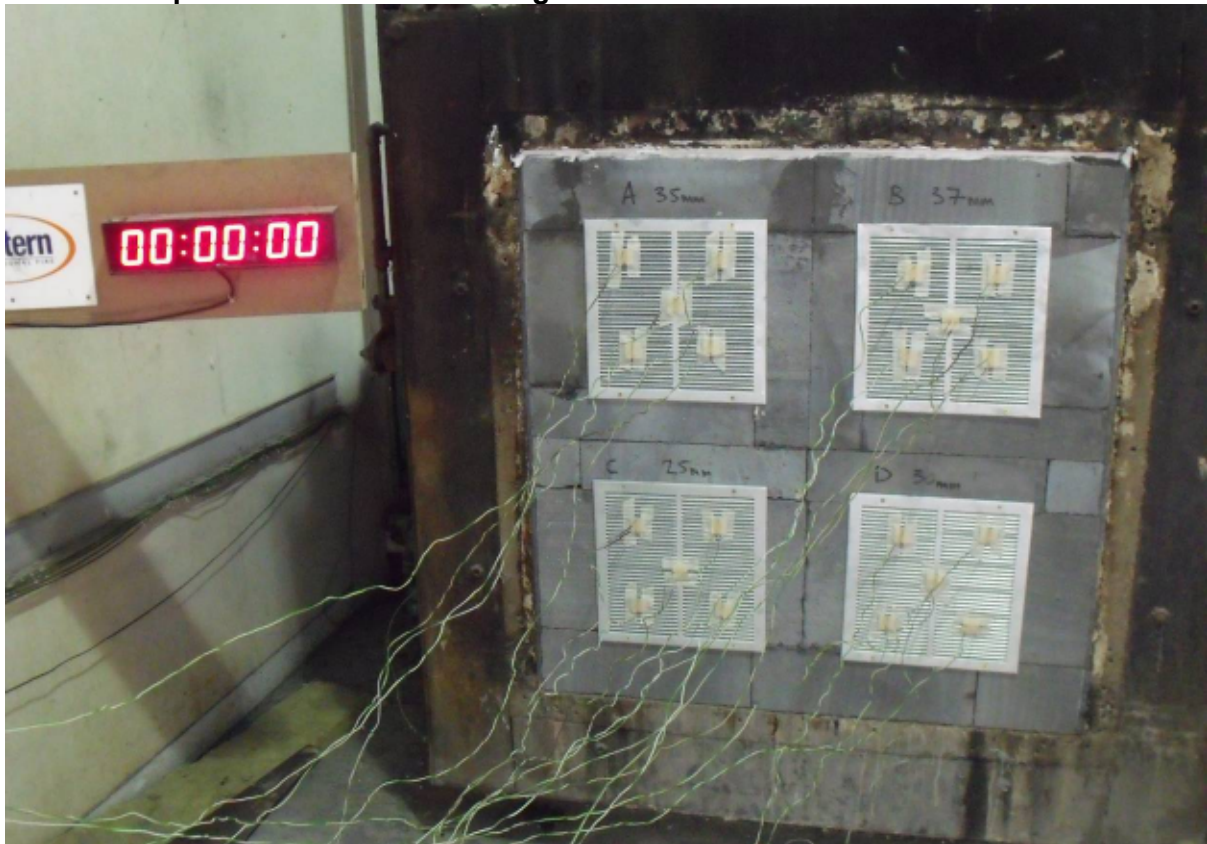
Unexposed face of air transfer grille blocks at start of test

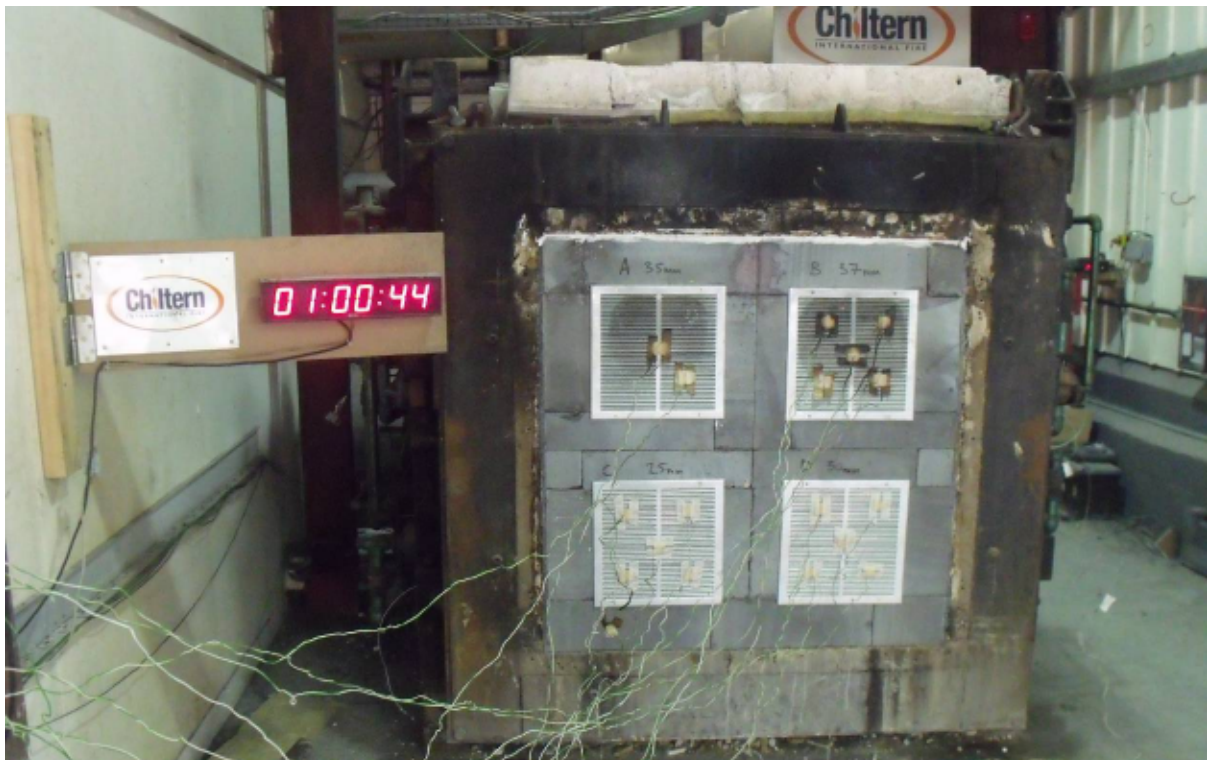
After 60 minutes

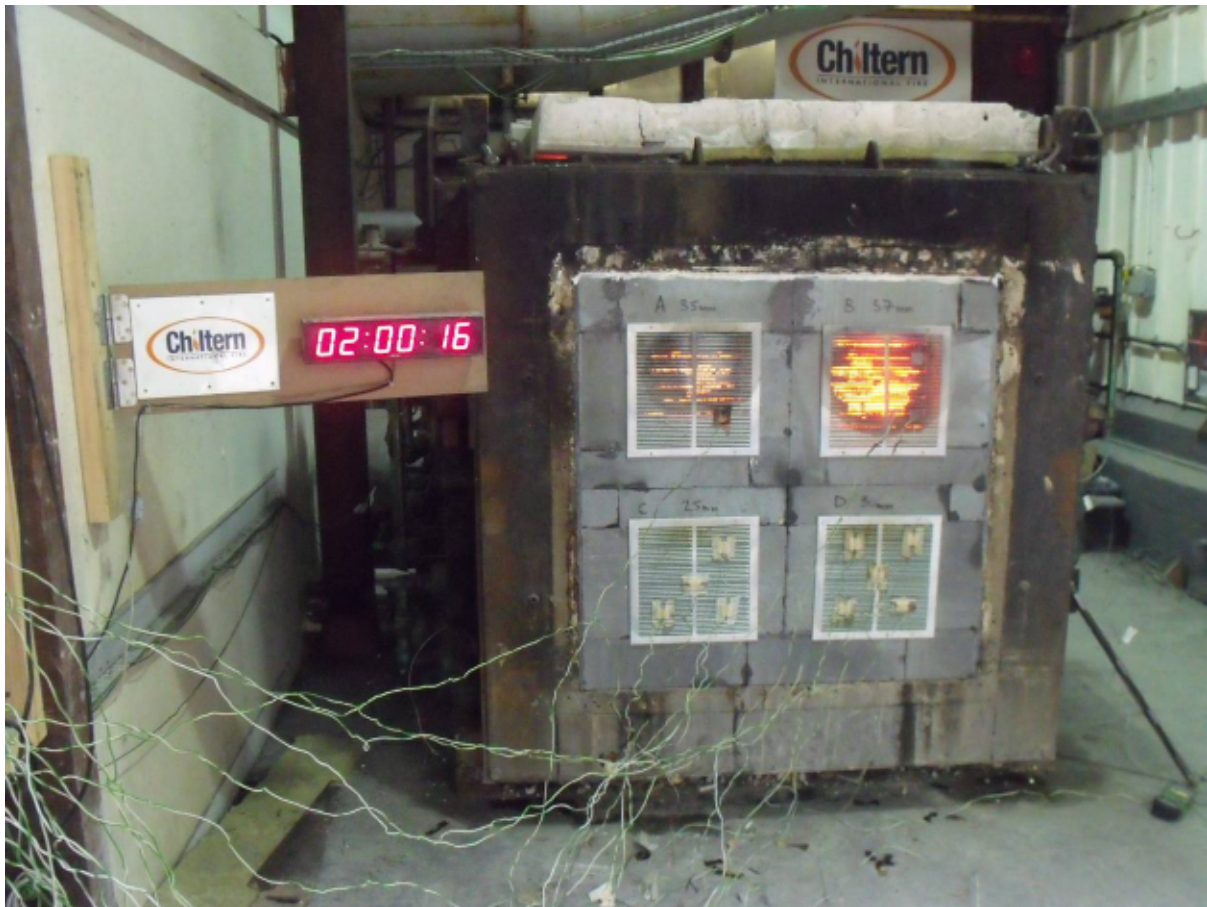
After 120 minutes

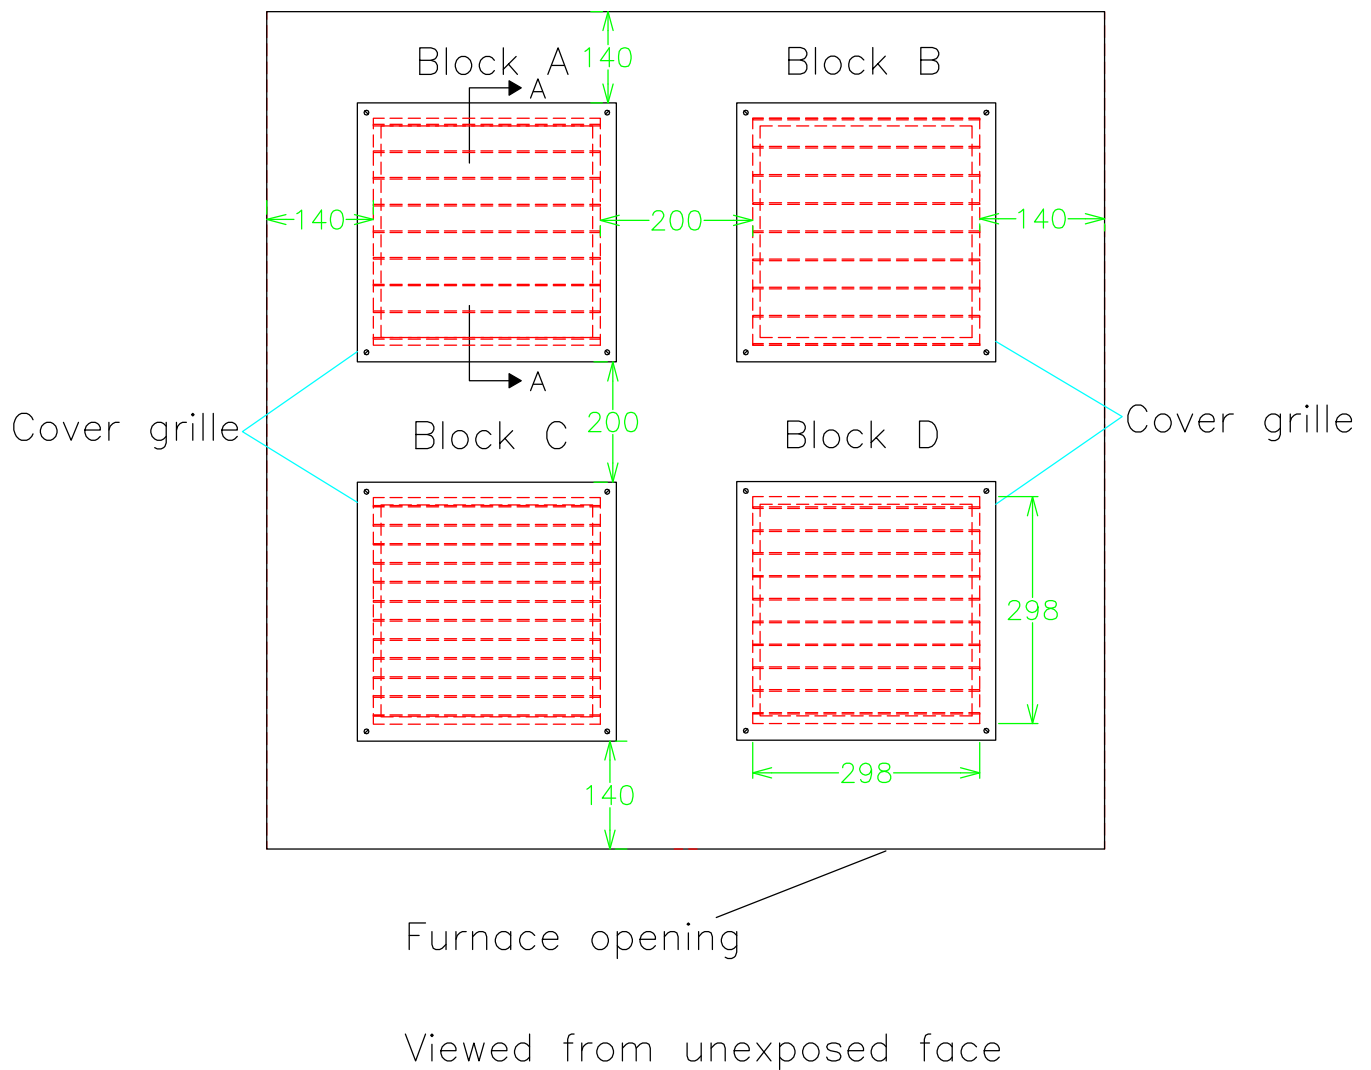
Title Unexposed face elevation  
of the wall construction  
(All dimensions in mm)

Each air transfer grille block measured 298mm high x 298mm wide x 40mm thick and were fitted 50mm from the unexposed face of the wall. Each grille block was located within the aperture by means of 4No. 50mm long wood screws, two on each face and then sealed to the wall with intumescent mastic. A 340mm high x 340mm wide steel grille cover was fixed to the wall with 50mm long wood screws, over the cut outs on both faces.

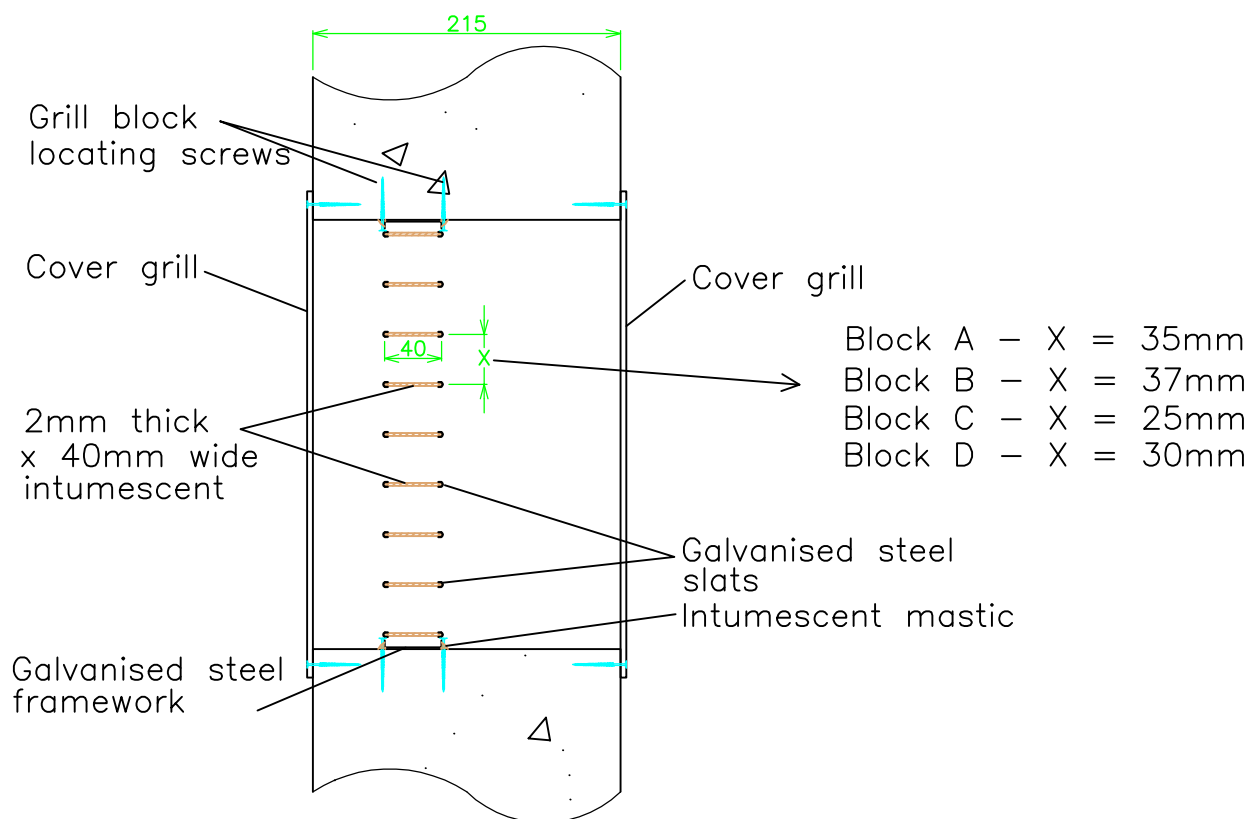
## Section A-A

Vertical cross section  
(All dimensions in mm)

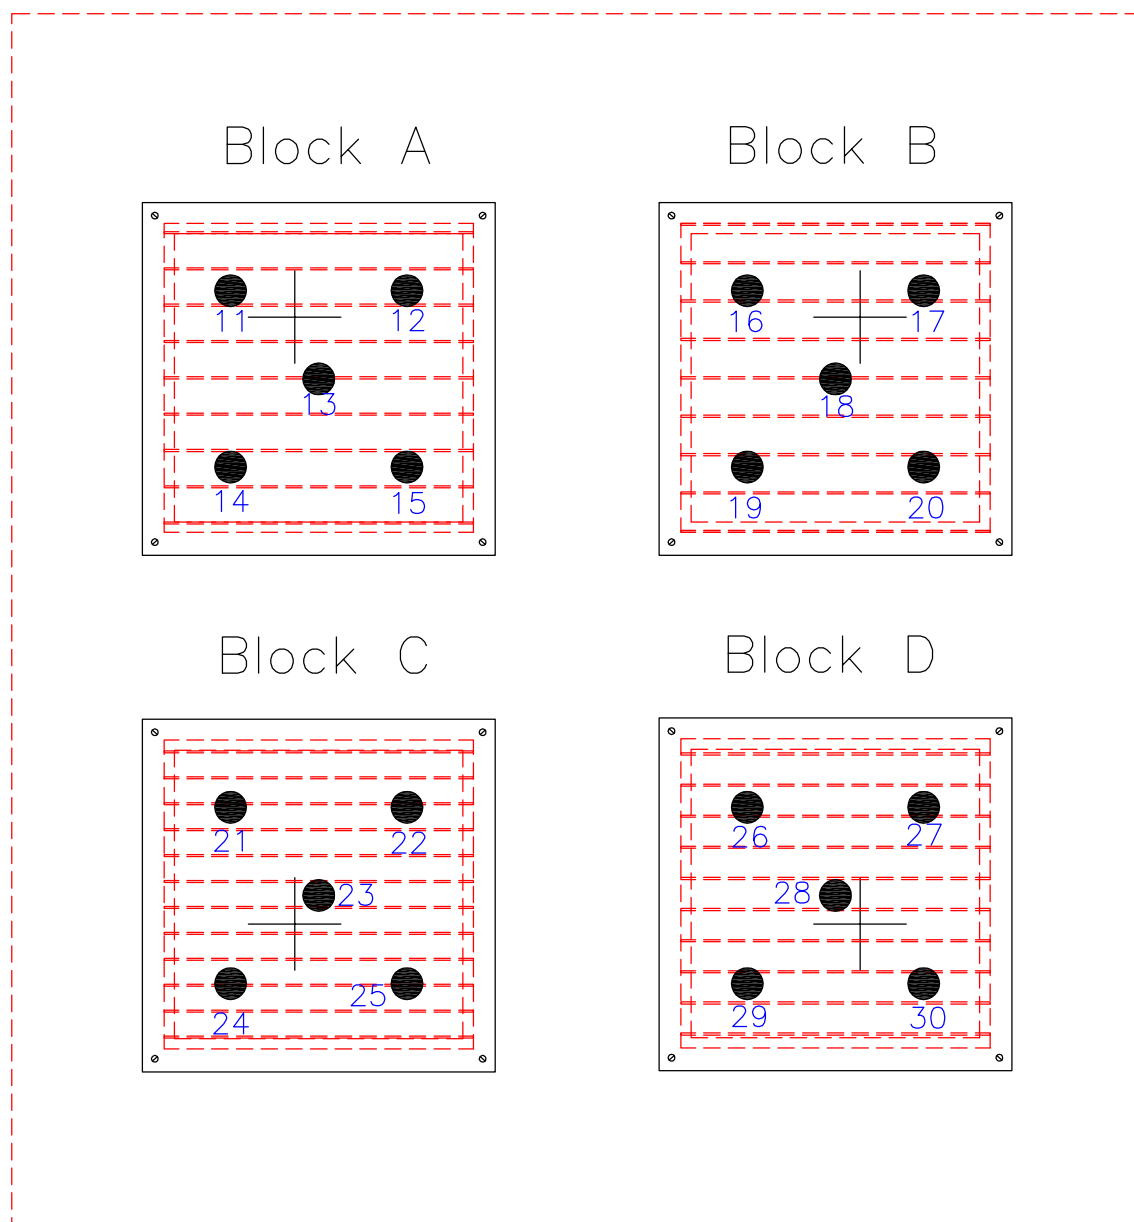
Title Unexposed face elevations  
showing thermocouple positions  
(All dimensions in mm)

The temperature of the unexposed face was monitored by means of five thermocouples fixed to each steel grille cover: (see Appendix figure 3)
